## AL SHIRAWI FACILITIES MANAGEMENT

### INCIDENT REPORT

<b>Incident Title</b>	SLS1 Main power trip from Zen Building no 3 - DG		<b>Date</b>	31.07.2021	<b>Incident No:</b> ASFM/TR/22/NSL058
			<b>Time</b>	10:30 Hrs	
<b>Site location information</b>	Near FIPS 3 & behind Bld 157				
<b>Building system</b> <small>(Highlight the category in red)</small>	Electrical	AC	Plumbing	S. System (Fire Fighting)	Others
<b>Impact on Client's operation</b>	<b>SLS 1 main power disconnected and working in Generator.</b>

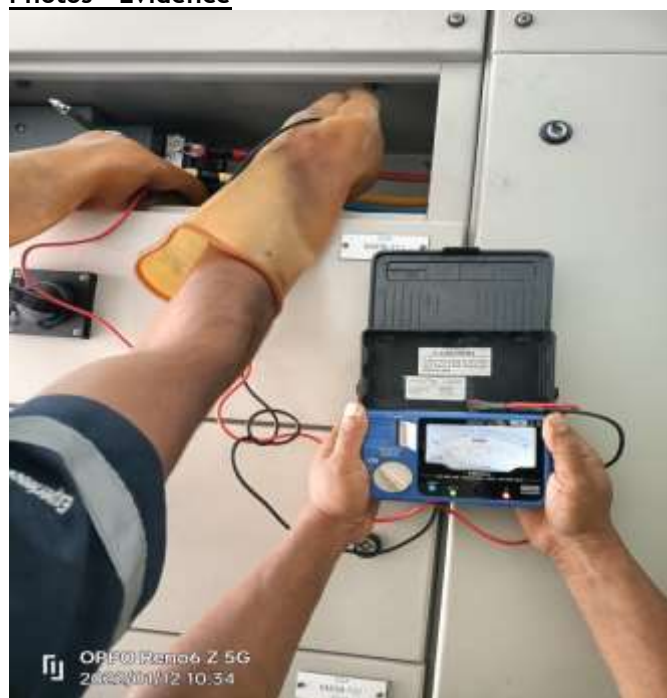
#### Photos - Evidence

Around 6.30 AM, ASFM SLS 1 pump room operator found the main power supply from Zen building no 3 LV room is tripped. At 6.40 AM ASFM has start the SLS 1 generator and initiated the pump operation to maintain the tank level. ASFM contacted the Zen building 3 maintenance team for the LV room access and they denied it without NOC from Distinguished Real Estates. At 8.30AM ASFM had the access permission and start the rectification work. During the inspection and megger test, we found the main power feeding cable has been short circuited.

Due to ageing and internal cable damage.

High Voltage Lightning Surge Generator and XLPE cable scanner required to identify the short circuit. Cable joint kit need to install as per standard to the identified faulty area.

Excavate and find out the cable damage. Installing cable joint kit and repeat the cable megger test.
