Incident summary and lessons learned

Scaffolding collapse at bloomingdale

Report Prepared by : Aneesh Sudersanan, HSE Manager

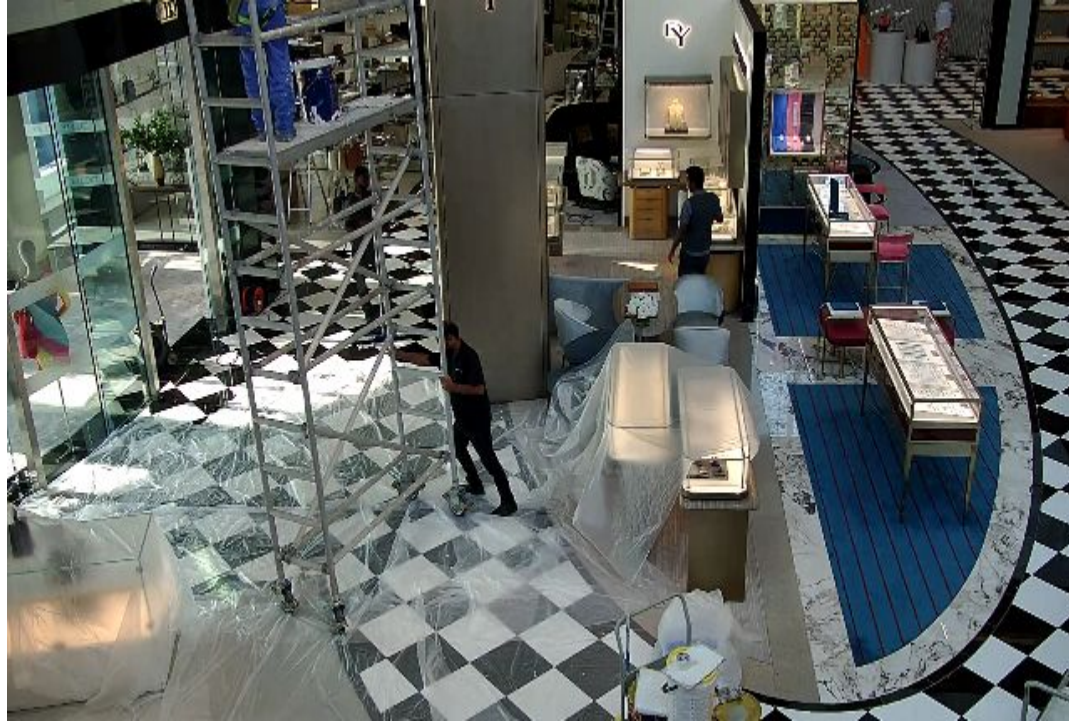
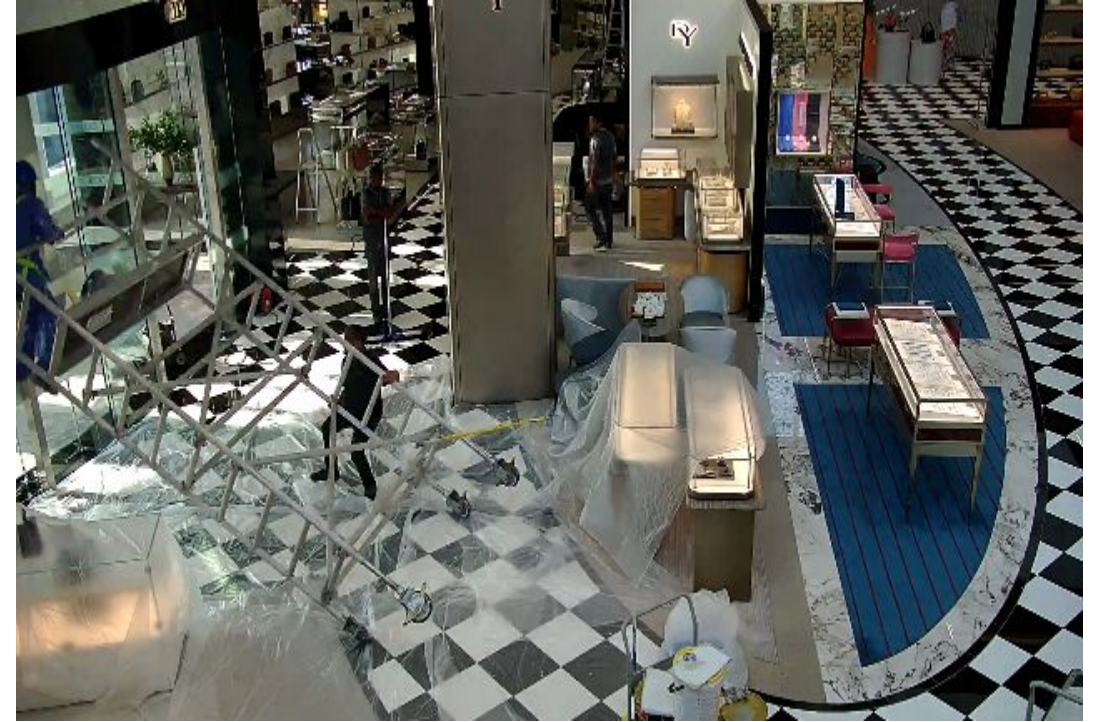
Incident Photographs

ASFAM technician Mr. Shailesh Kumar Sharma and the contractor employee Mr. Babban Kumar Tej was executing the job Team was using the scaffolding without outrigger and ASFAM technician Mr. Shailesh Kumar moved the erected scaffolding with Mr. Babban kumar on top caused the fall of scaffolding.

- a) The outriggers of the scaffolding was available however not used
- b) Green tag was not displayed on the scaffold by the scaffold inspector

- a) Scaffolding was used by the user without checking the green tag
- b) Scaffolding was pushed by the person standing below while a person was standing on the scaffolding platform

To prevent paint spillage on the floor a polythene sheet was spread on the floor and the scaffolding was above the polythene sheet, When The scaffolding was pushed the wheels may have got jammed and created an imbalance. This might have caused the scaffolding to topple.

- a) Appoint Competent supervision
- b) Conduct proper survey and inspection prior to issuing work permits specially on working at heights and other high risk activities.
- c) Ensure unsafe conditions are reported and rectified immediately
- d) Escalation matrix shall be duly followed in reporting incidents.
