INCIDENT REPORT Due Diligence Report
DUE DILIGENCE REPORT FOR LEAK AT DG74 APT 116

Incident Title	Water leak from Apt 216 master washroom to Apt 116 master washroom			Date	13.10.2021	Incident No:
				Time	10.15AM	Job No:
Site location information	Discovery Gardens Building 79					
Building system (Highlight the category in red)	Electrical	AC	Plumbing	S. System (Fire Fighting)	Others	
Impact on Client's operation	NA

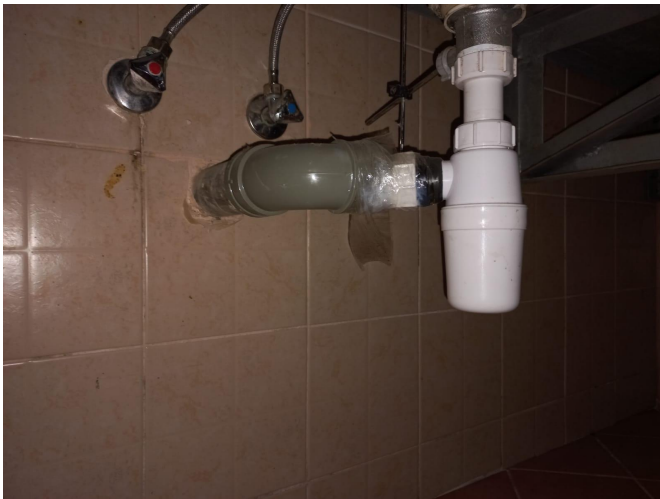
Wash Basin Drain pipe

DG74 Apt 216 master washroom drain pipe and waterproofing damaged.

DG74 Apt 216 has to arrange for the team to repair the water leak related issues which are affecting apt 116 master washroom. ASFM team will carry out the deep cleaning of the master washroom
If water marks are not removable it needs to be replaced.

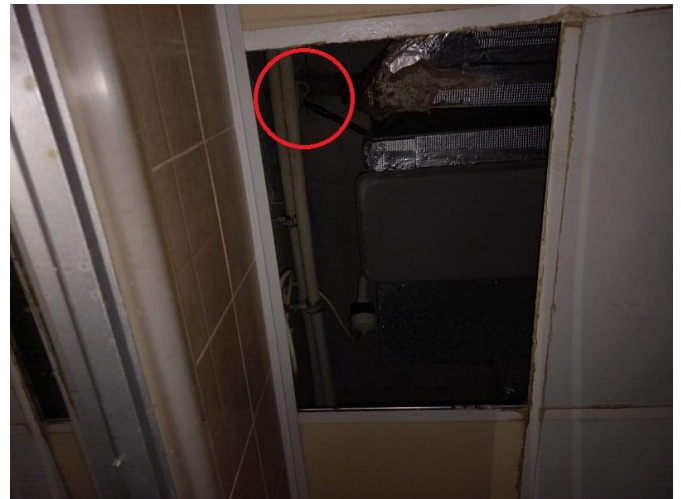
Based on the complaint, the ASFM team visited the unit and carried out the detail inspection and confirmed that the leaking water is coming from above apartment 216 master washroom, due to failure of wash basin drain pipe penetration seal (Waterproofing) and Bidet drain pipe damaged.

Wash basin drain pipe leaking at Apt116

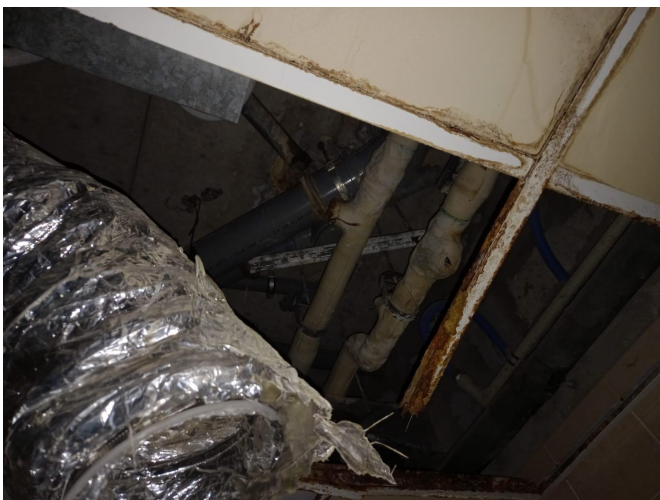
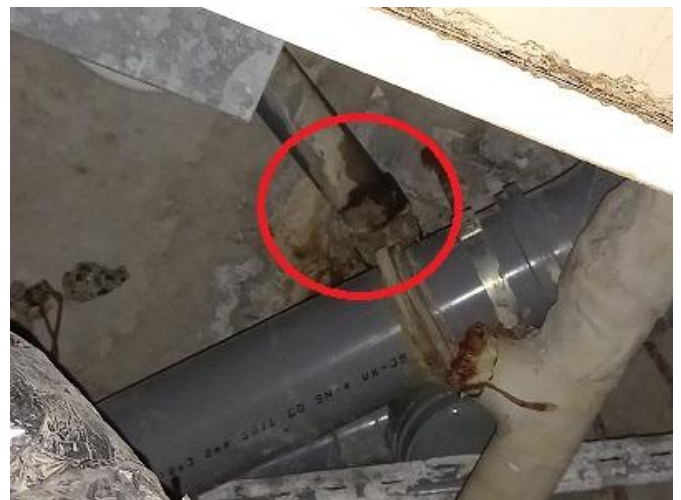
Bidet drain pipe leaking at Apt 116 master washroom ceiling

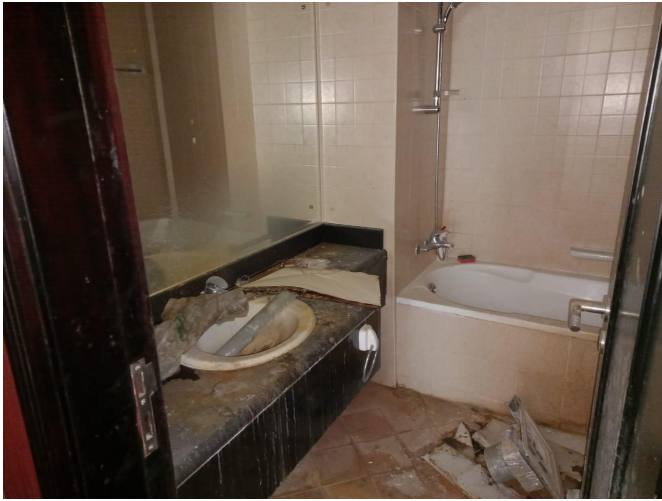
Apt 116 Water stain on the mirror, Wash basin & Counter

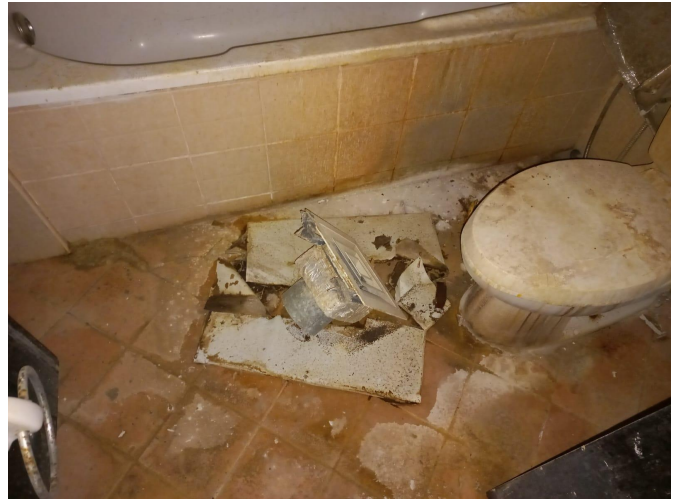
Apt 116 Water stains on the WC and Floor tiles

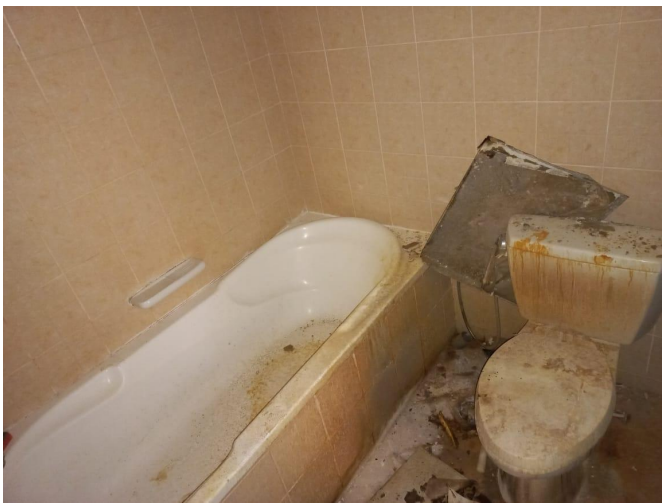
Apt 116-Water stain marks on the bathtub

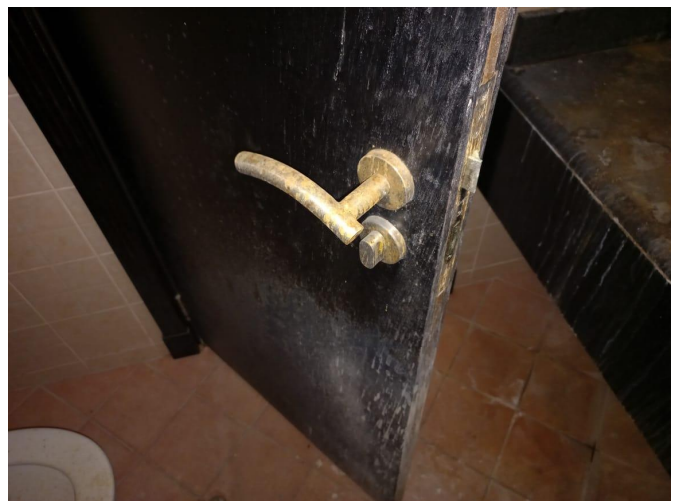
Apt 116- Water stain on the door handle

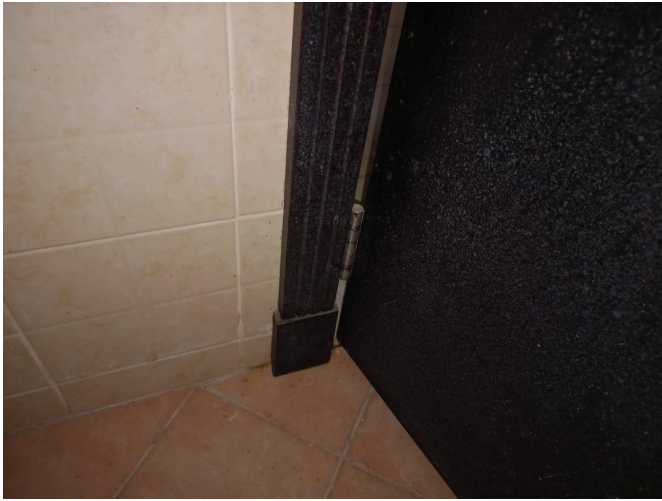
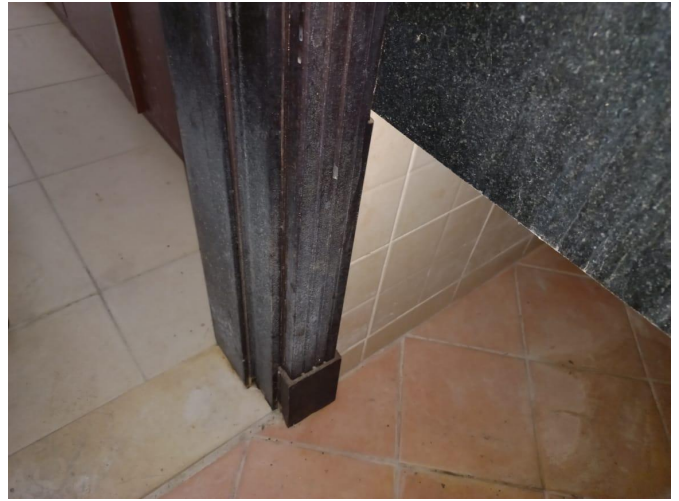
Apt 116- Water stain on the Door and door frame
