Incident summary and lessons learned

Scaffolding collapse at bloomingdale

Report Prepared by : Aneesh Sudersanan, HSE Manager

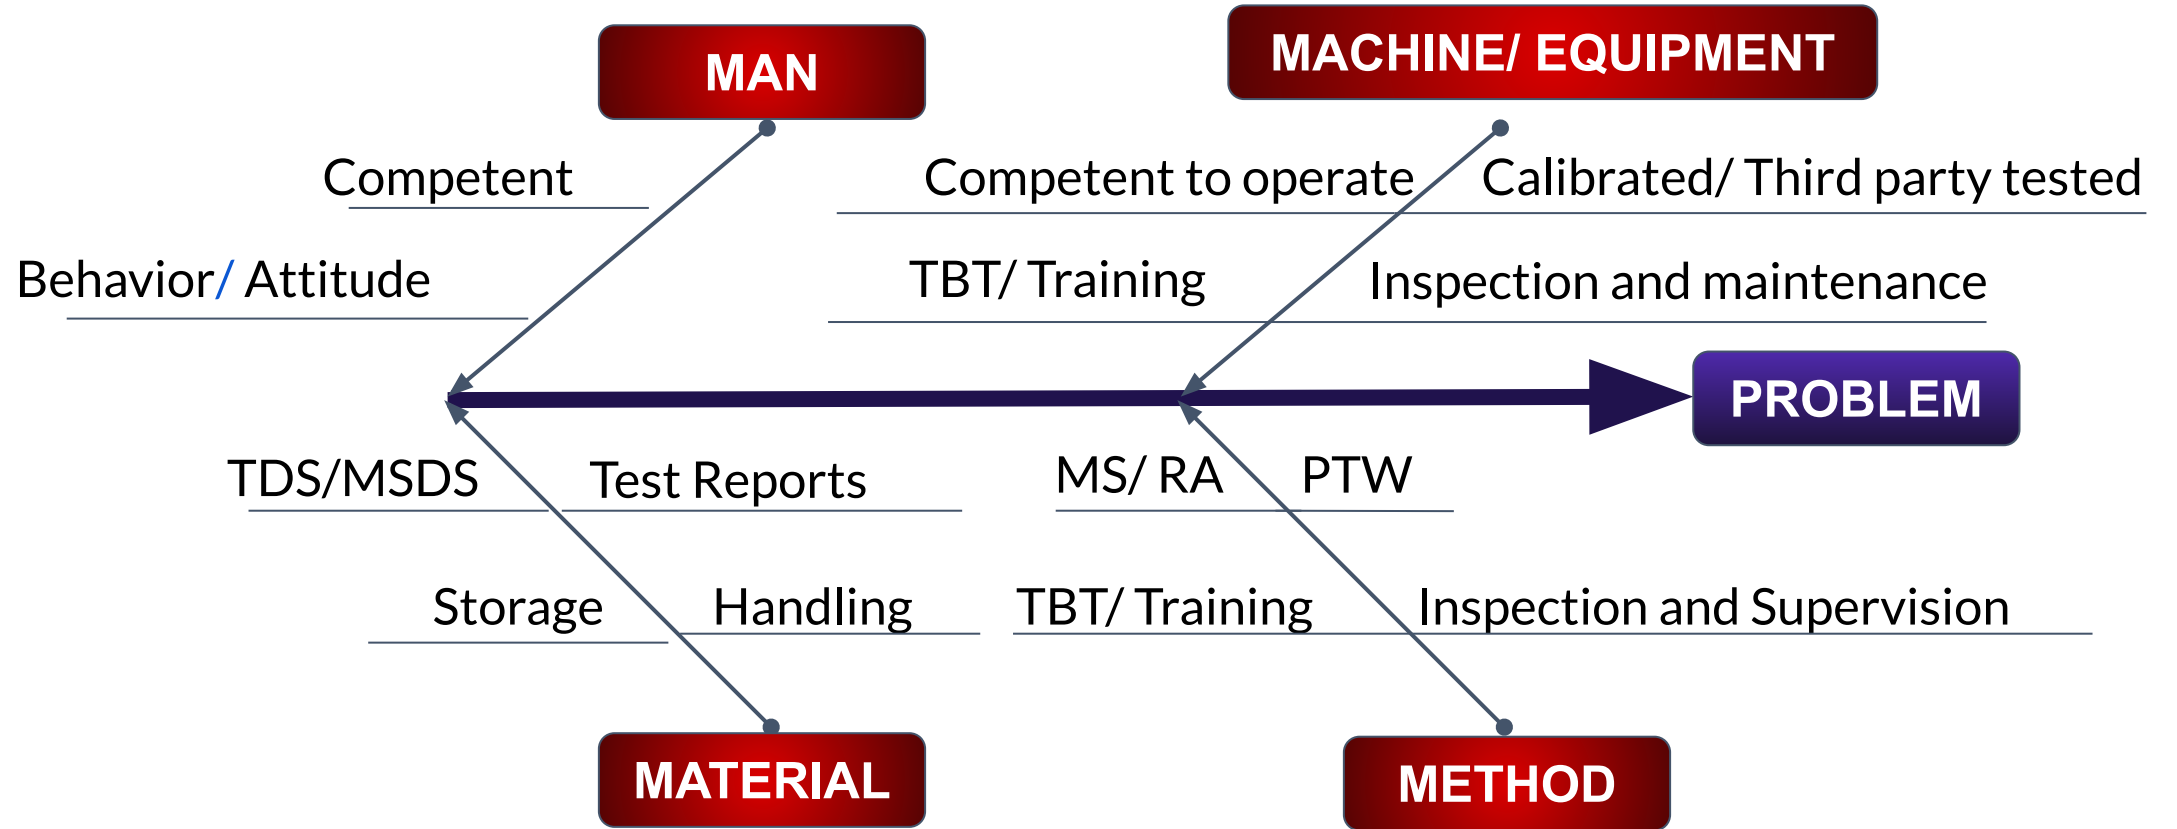
ASFAM technician Mr. Shailesh Kumar Sharma and the contractor employee Mr. Babban Kumar Tej was executing the job Team was using the scaffolding without outrigger and ASFAM technician Mr. Shailesh Kumar moved the erected scaffolding with Mr. Babban kumar on top caused the fall of scaffolding.

To prevent paint spillage on the floor a polythene sheet was spread on the floor and the scaffolding was above the polythene sheet, When The scaffolding was pushed the wheels may have got jammed and created an imbalance. This might have caused the scaffolding to topple.

- a) Appoint Competent supervision
- b) Conduct proper survey and inspection prior to issuing work permits specially on working at heights and other high risk activities.
- c) Ensure unsafe conditions are reported and rectified immediately
- d) Escalation matrix shall be duly followed in reporting incidents.
